## FIX-N-FAX

Number 87

### **MODEL #14 LOCKING HUBS (Only for those engines listed in this Fix n Fax)**

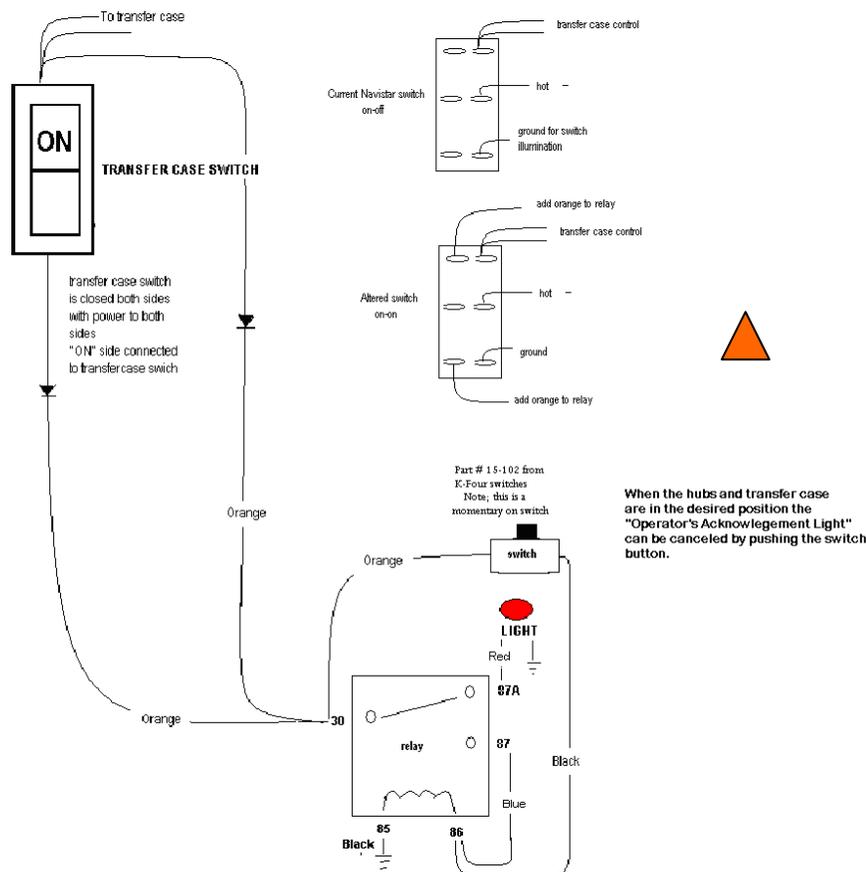
**Note: The transfer case switch has been internally altered from its original**

configuration. Replacements can be obtained from Davis Mobile Equipment.

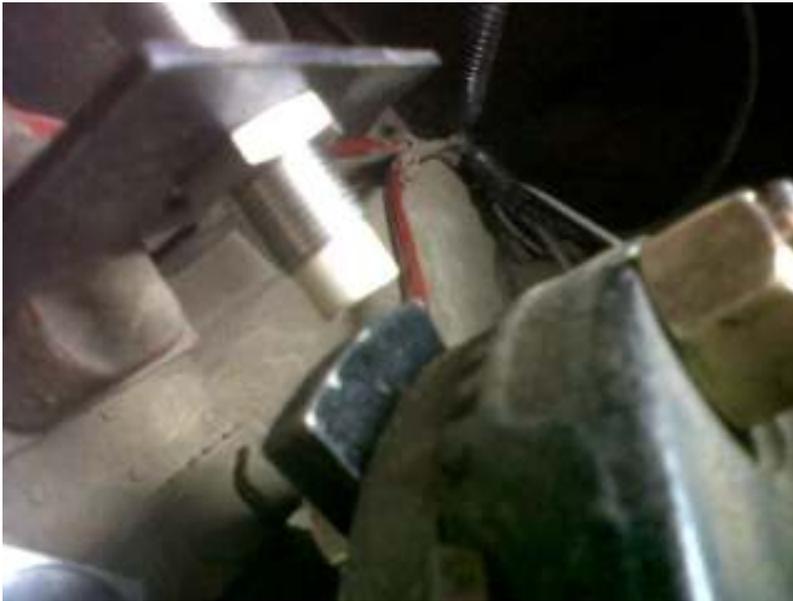
**The driveshaft rotation sensor must maintain a minimum .125 clearance between the sensor and the driveline lugs**

**Note: The warning light and buzzer will also activate if there is a broken wire or bad connection in the harness. There is a broken wire logic built into the ECM.**

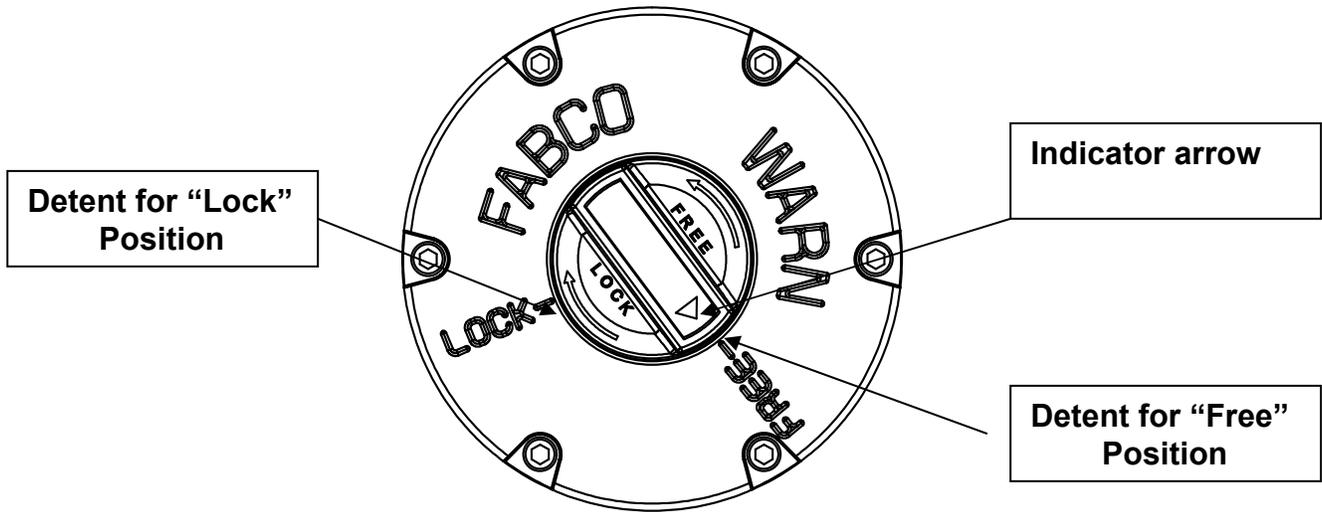
Figure 1

**CAUTION:** For proper operation, and **TO AVOID DAMAGE**, make sure the arrow and indicator mark on the hub lock are fully aligned and that both hub locks are set to the same position (**both set to “LOCK” or both set to “FREE”**).

1. Move the vehicle to a level surface, shift the transmission into neutral, set the parking brake, chock the tires, shift the transfer case into 2WD, and then rotate the indicator on both hubs to the “FREE” position. (see figure#1)
