FIX-N-FAX #82

CALIFORNIA DEPARTMENT OF FORESTRY AND FIRE PROTECTION

No. 82

Elkhart 1 ½ Discharge Valves

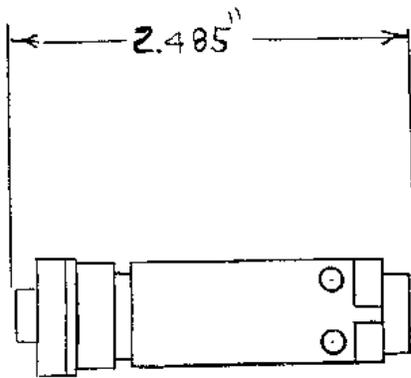
To check stem, measure the total overall length with micrometers; correct stem length should be 1.688" or 2.485". There are two different stems available (Ref. A and B diagrams.)

To repair this condition, verify the brass stem is the correct dimension when there is a ball failure.
