DOUBLE-BIT AXE

SHARPENING PROCEDURES

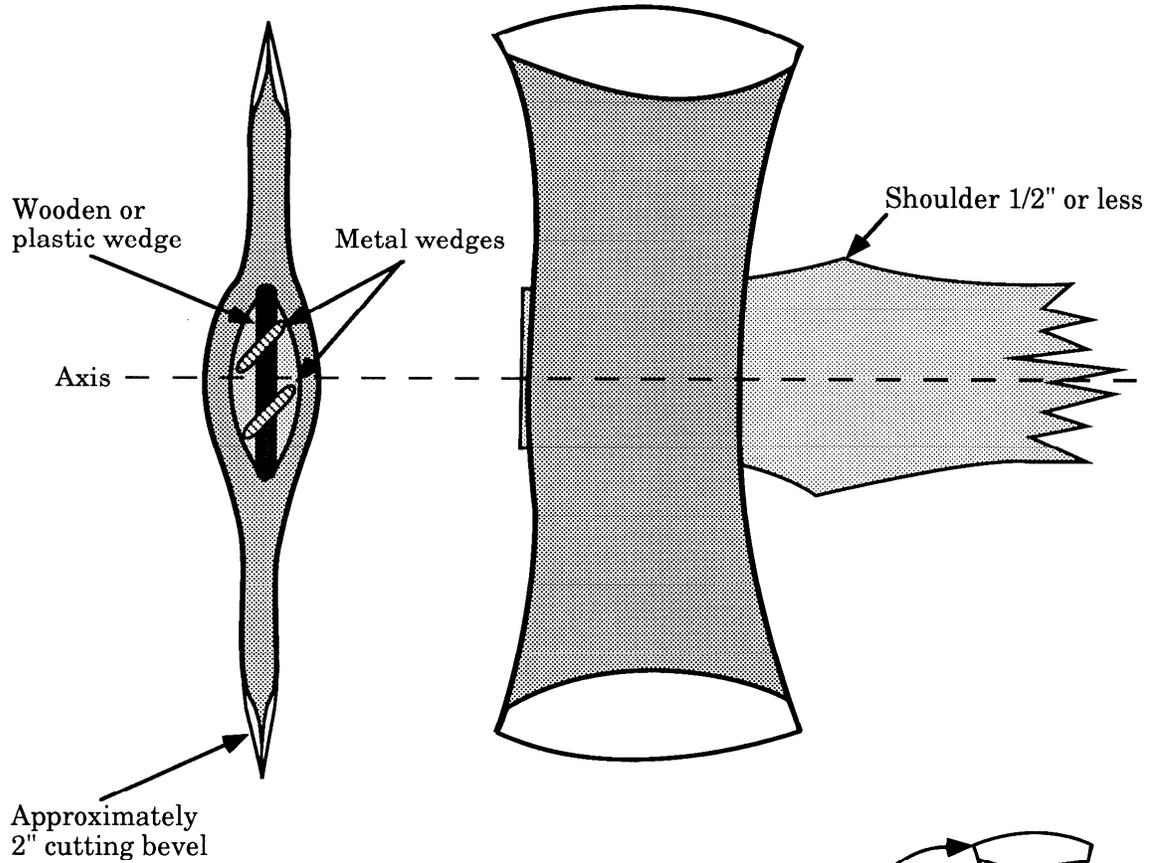
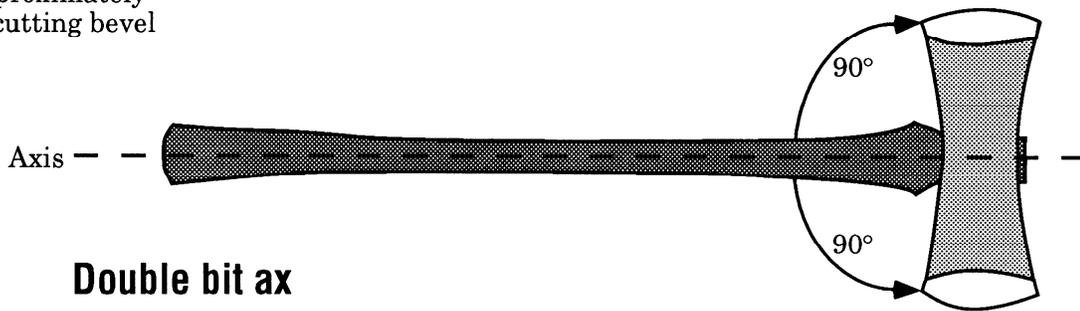
The axe at left was improperly used and maintained, resulting in the head becoming cracked and eventually chipping off, at the cutting edge.

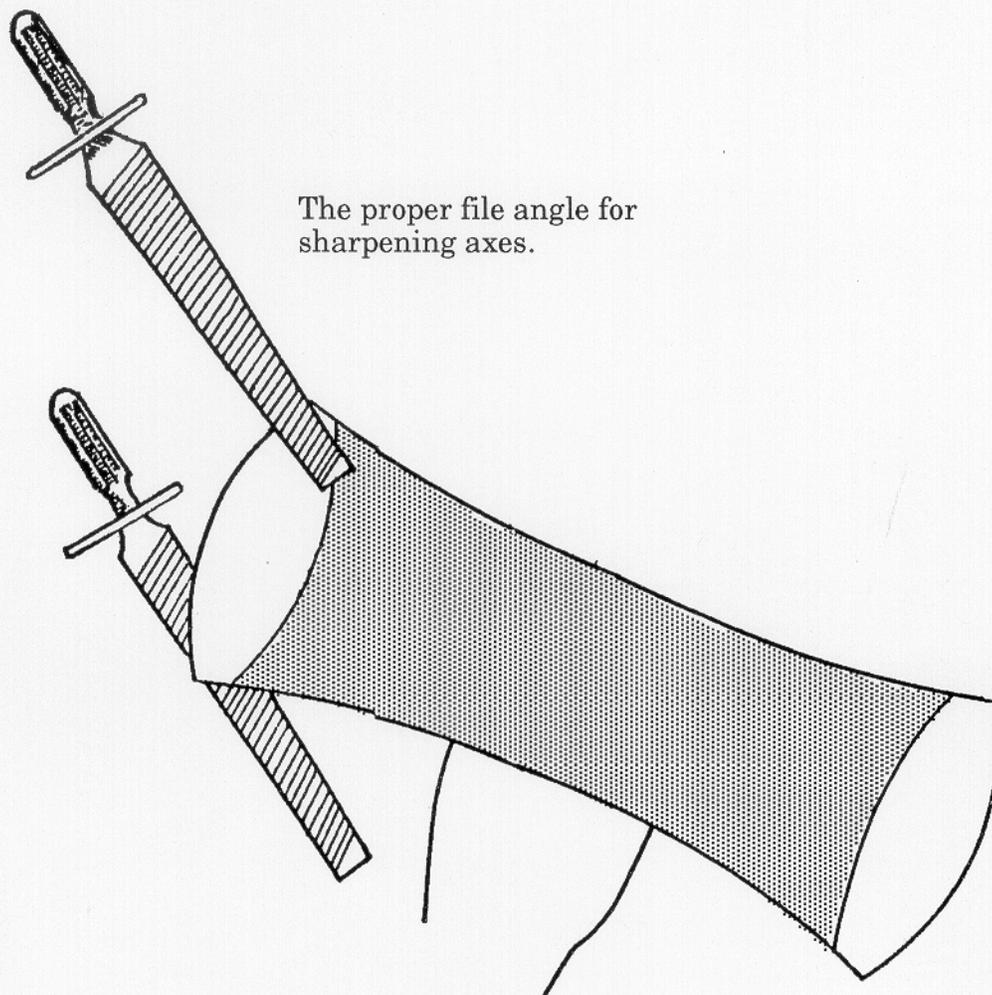
Secure tool in vise before sharpening. Use wood blocks to protect head from vise.

•Always use gloves and goggles while sharpening.
